# Experimental Study of Extended End-Plate Connections in Steel Moment Resisting Frames

FIKRY A. SALEM

Department of Structural Engineering, Faculty of Engineering  
Mansoura University, Mansoura, P.O. Box 35516, Egypt  
E-mail: drfikry\_salem@yahoo.com

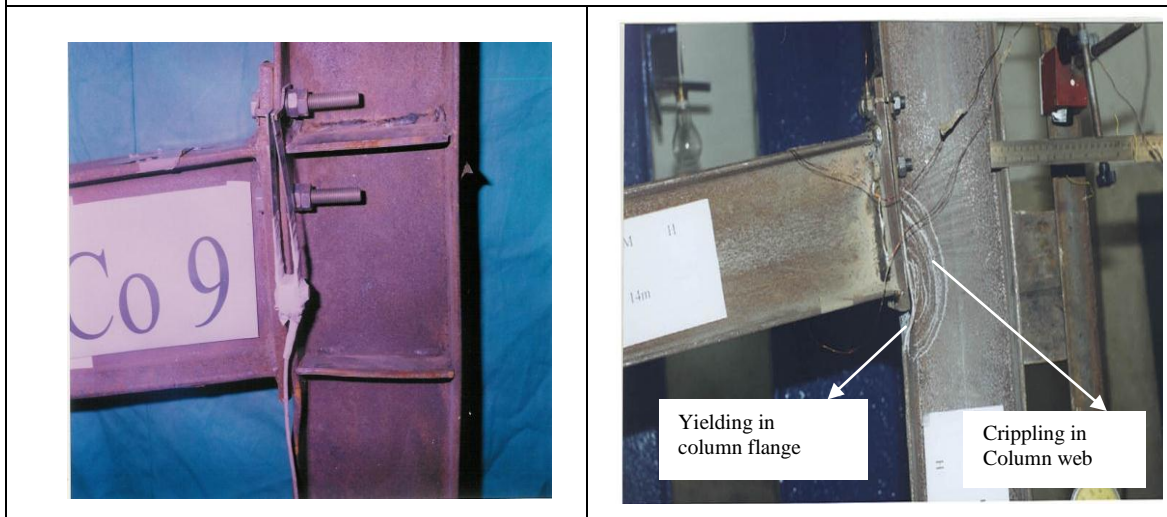
**Fig. (3): Clip Gage Apparatus and the Connected Connection**

The applied load is gradually increased till the failure occurs and this is controlled by using the stopwatch every 10.0 minutes. At each step of loading, the vertical deflections and strains at different positions are recorded. The strain in the bolts was measured by Clip Gage as shown in Fig. (3), the clip gage is connected to the test specimen in a way that it is supported to the aluminum slices. One slice is fixed between the head of the bolt and the end plate and the other slice is fixed between the nut and the flange of the column.

The main mechanism of the clip gage, when the clip gage is connected to the specimen the digital strain-meter reads an initial value, when the specimen is loaded and the bolt begins in deformation, in the same way the arms of the clip gage diverge or converge, and so the digital strain-meter reads another value, and so on.

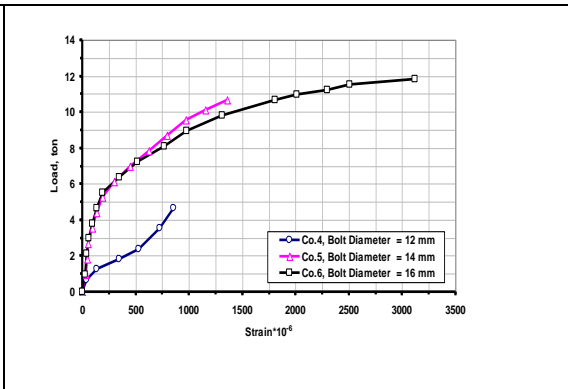
**Fig. (6):** Relation between the Load and Recorded Strains in End-plate till Failure for Tested End-Plate Moment Connections (Co.4, Co.5 & Co.6).

Referring to Table (2) and Figs. (6&11), for **group (II)**, it is noticed that, the measured longitudinal strains in the bolts of connections Co.6 & Co.5 reduced about 2 to 7 times the longitudinal strains in the bolts of tested connection Co.4 due to the change in the bolt diameter from 12 to 14 mm and from 14 to 16 mm respectively.

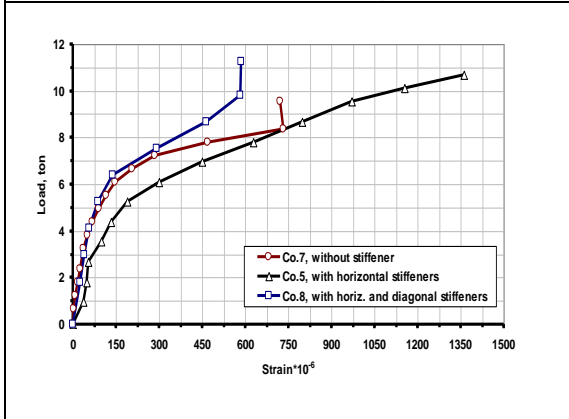
**Fig. (7):** Relation between the Load and Recorded Strains in End-plate till Failure for Tested End-Plate Moment Connections (Co.7, Co.5 & Co.8).

bolts and in the upper and lower flanges of the beam for the tested connections Co.7, Co.5 & Co.8 are given in Table (2) and Figs. (7& 12), it is noticed that the longitudinal strains in the bolts and end-plate and the upper and lower flanges of the beam are highly affected by the horizontal and diagonal stiffeners in the connections Co.5 and Co.8. The longitudinal strains in the bolts and end-plate of connection Co.8 which have horizontal and diagonal stiffeners decreased by 22.6 % and 49.7 % than the corresponding longitudinal strains in the bolts and end-plate of connection Co.5 with horizontal stiffener only respectively. Also, the measured longitudinal strains in the upper and lower flanges of the beam of connection Co.8 reduced by 83.5 % and 35.4 % than the corresponding longitudinal strains in the connection Co.5 respectively. While values of the strains in the different elements of tested connection Co.7 smaller values than the corresponding strains in the connections Co.5 & Co.8 due to the different modes of failure happened (crippling in column web and yielding in column flange) as shown in Fig.(4)

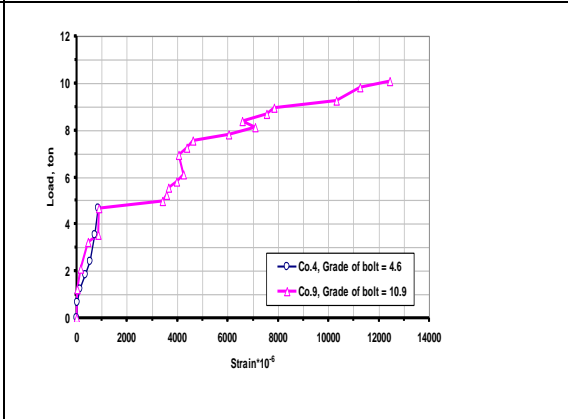
**Fig. (8):** Relation Between the Load and Recorded Strains in End-plate till Failure for Tested End-Plate Moment Connections (Co.4 & Co.9).

By referring to **group (IV)**, the measured longitudinal strains in the end-plate, in the bolt, and in the upper and lower flange plates of the beam for the tested connections Co.4 & Co.9 and Co.8 & Co.10 at load 4.67 ton are given in Table (2). Also, the load-strain curves till failure for these connections are shown in Figs. (8&9&13&14).

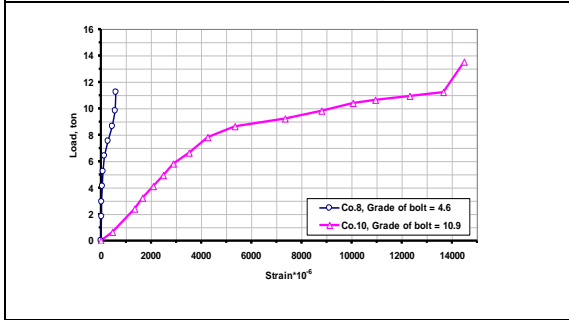
**Fig. (9):** Relation Between the Load and Recorded Strains in End-plate till Failure for Tested End-Plate Moment Connections (Co.8 & Co.10).

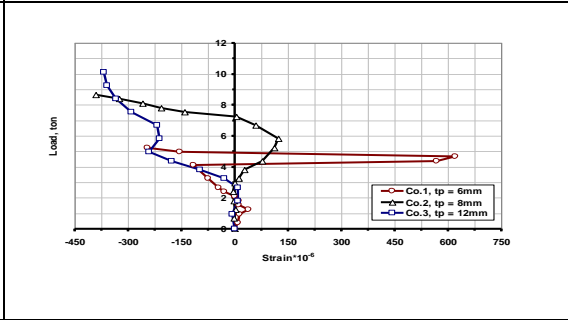
**Fig. (10):** Relation Between the Load and Recorded Strains in Bolt till Failure for Tested End-Plate Moment Connections (Co.1, Co.2 & Co.3).

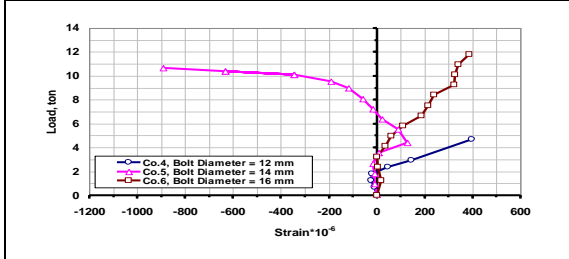
**Fig. (11):** Relation Between the Load and Recorded Strains in Bolt till Failure for Tested End-Plate Moment Connections (Co.4, Co.5 & Co.6).

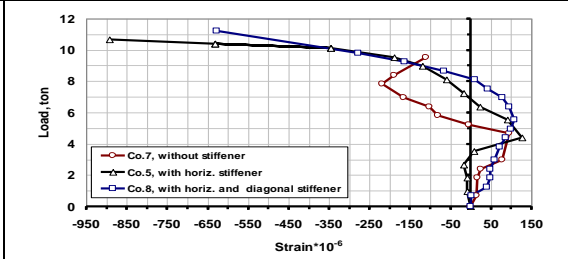
**Fig. (12):** Relation Between the Load and Recorded Strains in Bolt till Failure for Tested End-Plate Moment Connections (Co.7, Co.5 & Co.8).

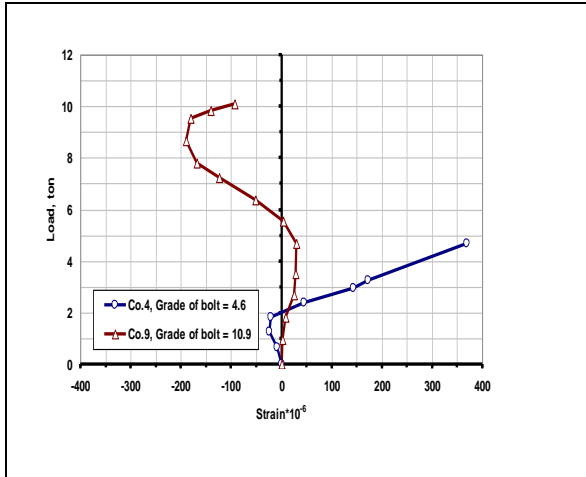
Fig. (13): Relation Between the Load and Recorded Strains in Bolt till Failure for Tested End- Plate Moment Connections (Co.4 & Co.9).

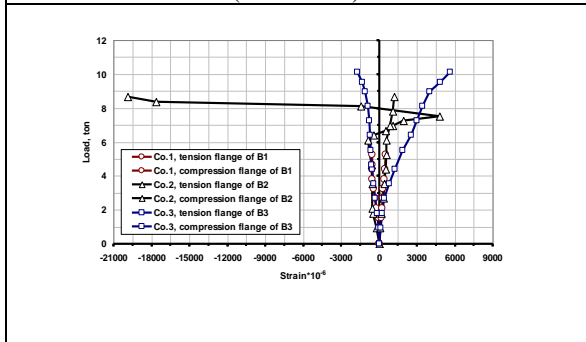
Fig. (15): Relation between the Load and Recorded Strains in the Upper and Lower Beam Flanges till Failure for Tested End-Plate Moment Connections (Co.1, Co.2 & Co.3).

Figures (5) to (24) show the measured longitudinal strains in the end-plate, in the bolt, and in the upper and lower flange plates of the beam in all the tested connections. Table (2) also gives the recorded longitudinal strains of all tested connections. From table and figures (5&15), it is noticed that, for **group (I)**, the recorded longitudinal strains in end-plate of tested connection Co.2 which have end-plate thickness 8 mm decreased by 58 % than the corresponding strains of tested connection Co.1 with end-plate thickness 6 mm. Also, the longitudinal strains in end-plate of connection Co.3 which have end-plate thickness 12 mm decreased by 57.7 % than the corresponding strains of connection Co.1 which have end-plate thickness 6 mm. While the longitudinal strains in the upper and lower flanges of the beam in connections Co.1, Co.2 & Co.3 gradually increased due to increase in the end-plate thickness from 6 mm to 12 mm.

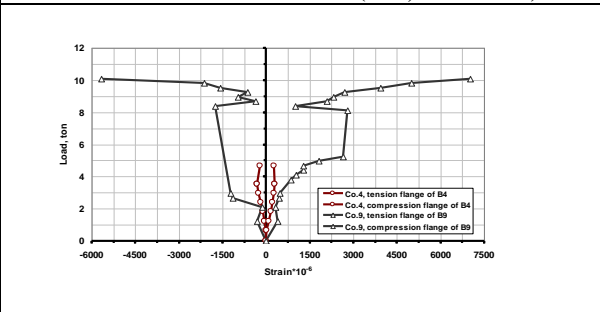
Fig. (18): Relation between the Load and Recorded Strains in the Upper and Lower Beam Flanges till Failure for Tested End-Plate Moment Connections (Co.4 & Co.9)

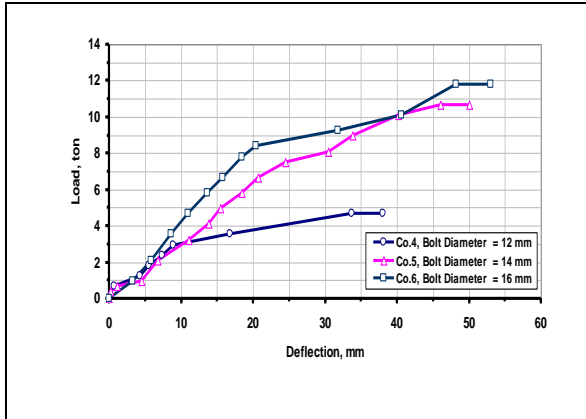
Fig. (21): Relation Between the Load and Recorded Deflections at the End of the Beam till Failure for Tested End-Plate Moment Connections (Co.4, Co.5 & Co.6).

For **group (II)** with different types of the bolt diameter in the tested connections Co.4, Co.5 & Co.3, it is also noticed that, , the maximum deflections at the end of the

beam under the applied load decreased due to the increase in the bolt diameter from 12 to 14 mm and from 14 to 16 mm. While for **group (III)** where the horizontal and diagonal stiffeners are studied, it is noticed that, the recorded deflections under the applied load for tested connections Co.5 & Co.8 were not effect by using the different types of stiffeners.

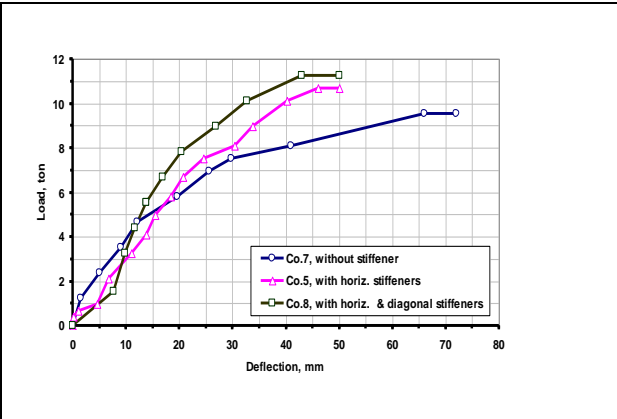
Fig. (22): Relation Between the Load and Recorded Deflections at the End of the Beam till Failure for Tested End-Plate Moment Connections (Co.7, Co.5 & Co.8).

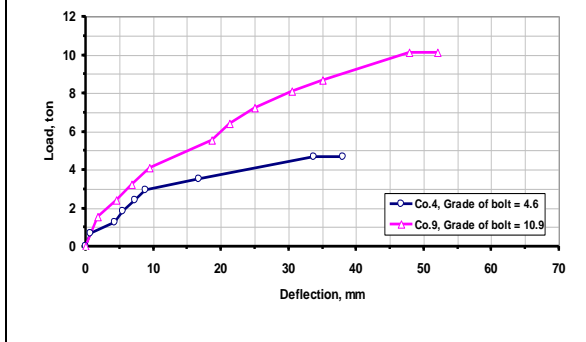
Fig. (23): Relation Between the Load and Recorded Deflections at the End of the Beam till Failure for Tested End-Plate Moment Connections (Co.4 & Co.9)

Also, for **group (IV)** where the grade of bolts is investigated, it is noticed that, the measured deflections under the applied load for tested connections Co.4 & Co.9 and Co.8 & Co.10 were nearly constant.

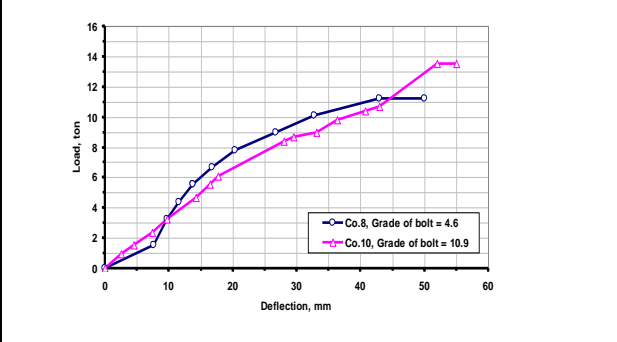
Fig. (24): Relation Between the Load and Recorded Deflections at the End of the Beam till Failure for Tested End-Plate Moment Connections (Co.8 & Co.10)

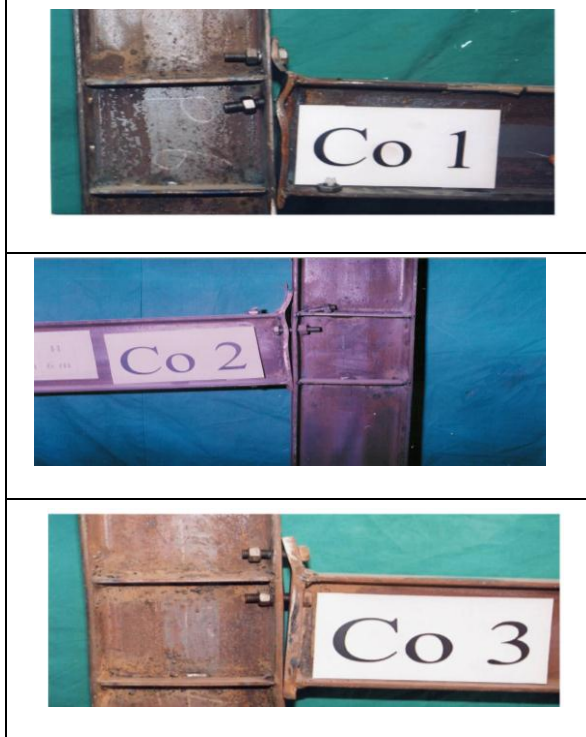
Fig. (25): Modes of Failure for the tested connections (Co.1, Co.2 & Co.3) in the group I
