## BEHAVIOR OF PRECAST PRESTRESSED HOLLOW CORE SLABS WITH OPENINGS: EXPERIMENTAL STUDY

A. F. EL-khouly, N. N. Meleka, M. A. Tayel, and K. M. Heiza.

*Department of Civil Engineering, Faculty of Engineering  
Menoufia University, Egypt*

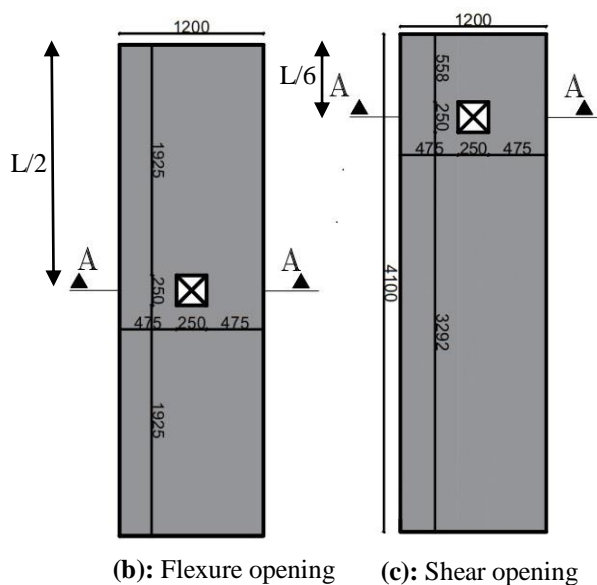
Fig. 2: Openings locations for PPHCS2 and PPHCS3

with a diameter of 9.3 mm. In the second specimen, to make the opening one strand (the mid strand) had to be cut. The cross section of the control specimen is shown in Fig. 1 and openings locations for other specimens are shown in Fig. 2.

(b): Flexure opening (c): Shear opening

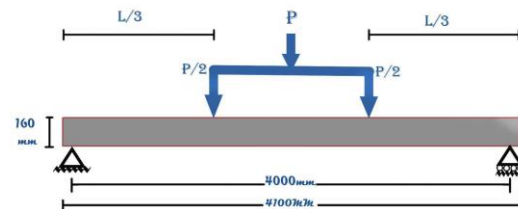
Fig. 3: Schematics of experimental setup

The specimens were tested under four point bending as illustrated in Fig.3. They were simply supported on the short edges. A 500 kN hydraulic jack was used to apply the load which was transferred to the slab using a rigid longitudinal spreader beam. Two transverse I beams were used for applying uniformly distributed line loads along the width of slabs. The bottom simple supports were achieved using two I beams. The support and loading I beams were sufficiently stiffened to avoid any local buckling failure. The load was applied gradually for all the specimens tested in this study with constant value (5 kN per increment). Loading was paused intermittently to observe the failure progression, marking of cracks and get the dial gauge readings. The instrumentation of the specimens is shown in Fig.4.

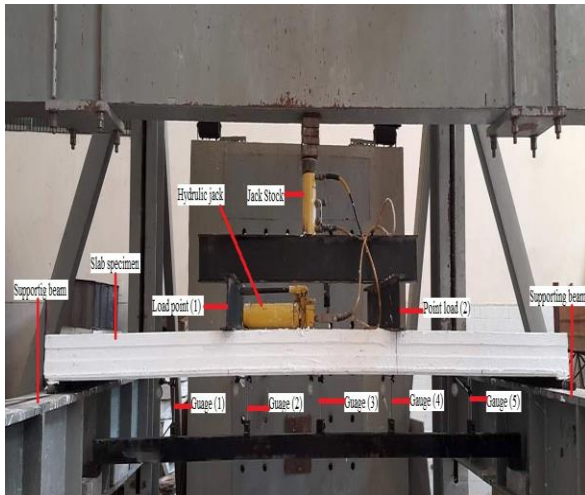
Fig. 4: Test setup and instrumentation

Five dial gauges were installed to measure the deflections at different points of the tested slab. One dial gauge was placed at mid-span, two dial gauges were placed under line loads, and last two dial gauges were placed at mid of one-third of span to measure deflection. The testing equipment and the test setup are shown in Fig.4.

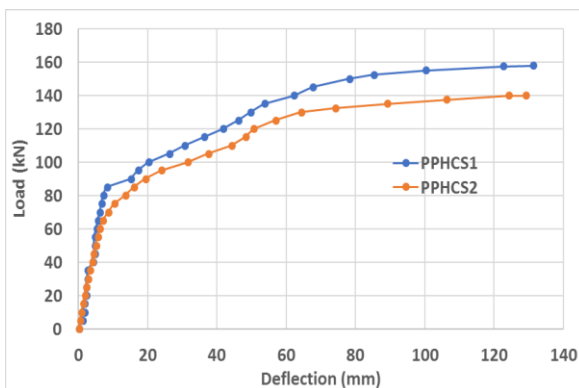
Fig. 5: Load-Deflection curve at mid-span for PPHCS1 and PPHCS2

Load deflection curves of PPHCS1 and PPHCS2 at mid of span and under line load are presented in Fig. 5 and Fig. 6; respectively. The load deflection curve for control slab (PPHCS1) shows a typical under-reinforced behavior for bending stresses. The slab was cracked in flexure at the bottom fiber after the tensile strength of concrete had reached. Cracking was reflected through a change in slope of the load-displacement curve. With further increase in the applied load, strands started resisting the load until their yielding. Soon after the yielding of the strands, load displacement curve flattened and no further increase in load resistance was observed. For second series (PPHCS2) load deflection curve shows same behavior of control slab but with decrease in the stiffness and capacity of the slab which is affected by the opening.

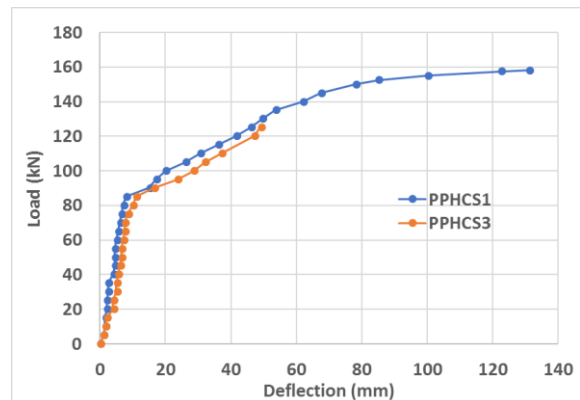
Fig. 7: Load-Deflection curve at mid-span for PPHCS1 and PPHCS3

The load deflection curves of PPHCS1 and PPHCS3 at mid of span and under line load are shown in Fig.7 and Fig. 8; respectively.

For PPHCS3, during the first elastic range the specimen showed a very similar behavior as that of the PPHCS1. PPHCS3 specimen was still capable to resist load beyond the elastic range. Suddenly, the PPHCS3 specimen failed at an ultimate load of 125 kN.

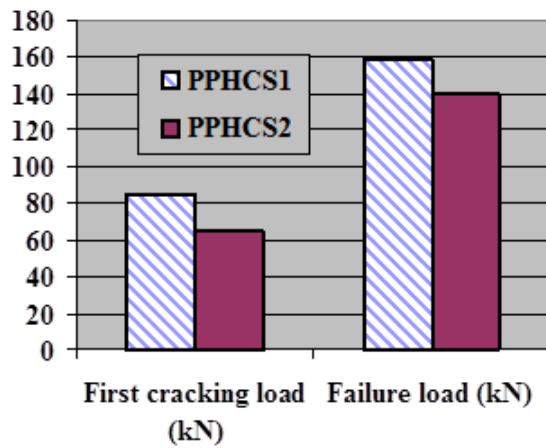
Fig. 9: Test results of PPHCS1 and PPHCS2 slabs

First flexural crack in the control slab was observed at the tension region in the constant moment zone. Fig (9) shows that the first cracking loads were 85 kN and 65 kN for PPHCS1 and PPHCS2; respectively. More distributed cracks formed with further increase in loads along the length of specimen as shown in Figs 10, 11 and 12. Significant displacement ductility was observed at the failure indicating an under reinforced failure mode. Also, the failure loads were 158 kN for PPHCS1 and 140 kN for PPHCS2 specimens.

1. Making an opening at mid of span reduced the stiffness and decreased the flexure capacity of the slab. The first cracking load was decreased by about 23.50%, and the failure load was decreased by 11.40% with respect to control slab results.
2. The opening at mid span did not affect the failure mode as it remained ductile as control slab specimen.
3. For the opening at mid of one third of span (at max shear), as there is no steel to resist the shear (only concrete) the opening had a very severe effect on slab at this zone as the specimen failed suddenly. The first cracking load and failure load was decreased by about 6% and 21%; respectively with respect to control slab.

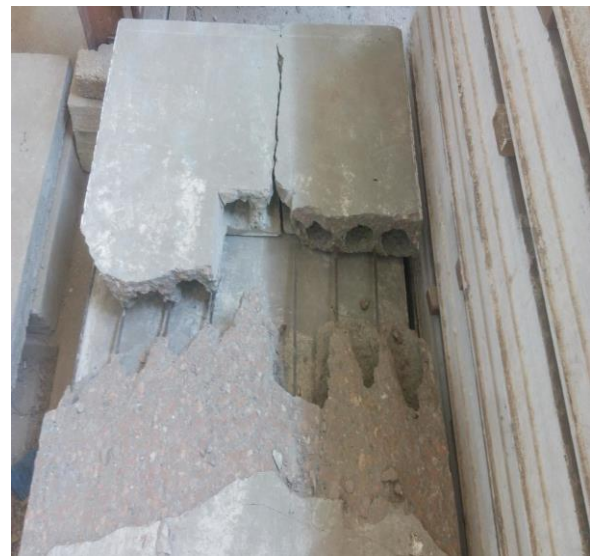
Fig. 13: Failure and Cracks pattern for PPHCS3

For PPHCS3, first flexural crack in the specimen was observed at the tension region in the constant moment zone. The first cracking load was 80 kN. Suddenly, specimen PPHCS3 failed at an ultimate load of 125 kN. The failure mode is shown in Figs 13. The comparison of first cracking load and failure load between PPHCS1 and PPHCS3 is shown in Fig. 14.
