Tempering of AISI 416 Martensitic Stainless Steel تليين الصلب ٤١٦ (المارتنيسيتي) القارم للصدأ

M.A. El-Hady

Department of Metallurgical Engineering Faculty of Petroleum and Mining
Engineering, Suez, Egypt.

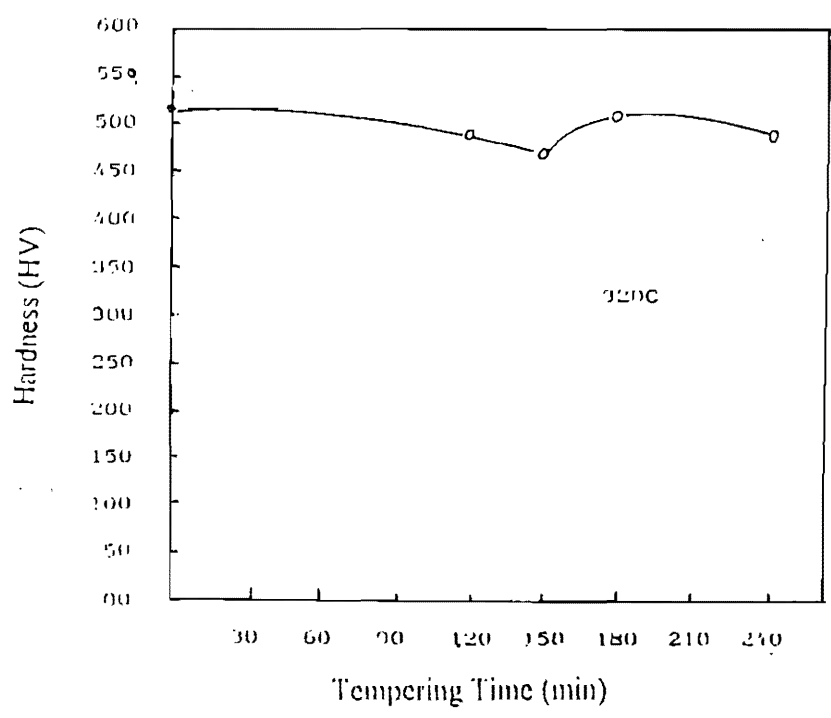
Fig. (1): Shows the change in microhardness (HV) as a function of time for different tempering temperatures. (200, 320, 400, 500, 600, 700, 800, 900).

Fig. (1): Shows the change in hardness as a function of time for different tempering temperatures.
